ENGINEER'S REPORT
of the
JARRED BRYAN SPARKS INCIDENT

By:
Ronald J. Natoli, P.E.
and
Nancy Grugle, Ph.D.

June 26, 2014

Robson Forensic
Engineers, Architects, Scientists & Fire Investigators

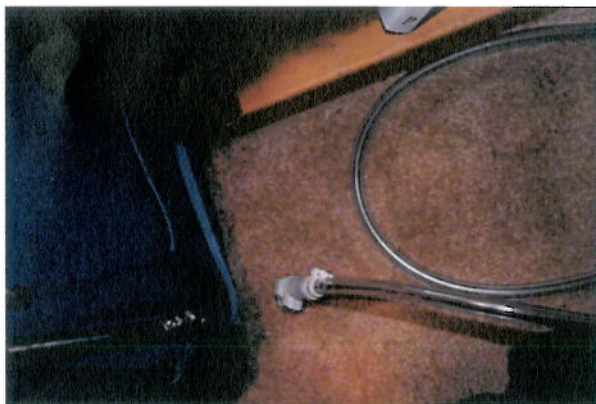
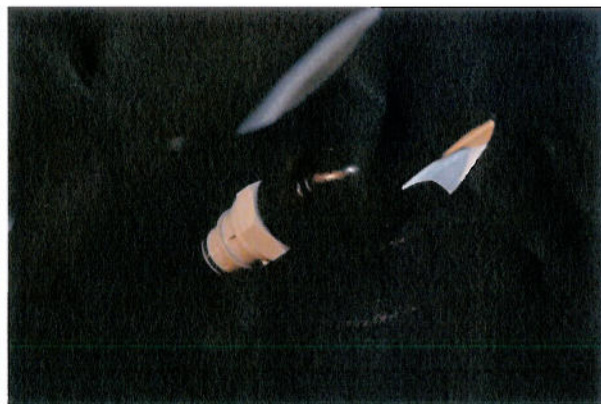
Photo 1

Detective Mincey noted that when he arrived, the air tube that supplies pressure/fresh air to the chamber was disconnected and coiled on the floor (See Photos 1 & 2).

The second smaller tube that supplied oxygen was still connected. The detective's investigation revealed that a clear plastic container containing miscellaneous items inside was on the book shelf (see Photo 3).

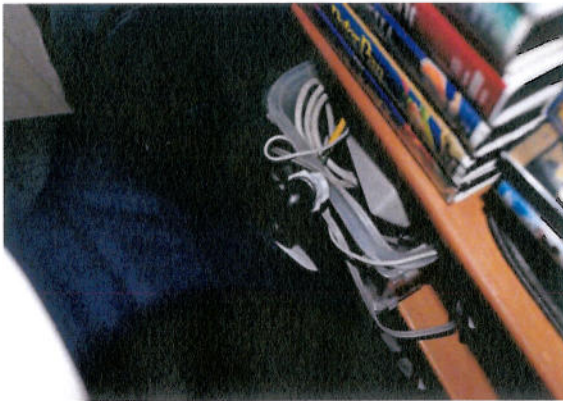
Photo 3

When referring to the quick disconnect connection (see Photo 4 – Jan 8, 2014 inspection photo) supplied with the Oxy Health Vitaeris 320, the detective reported that “the button subsequently was being pressed by the clear plastic container lip” (see Photo 3).

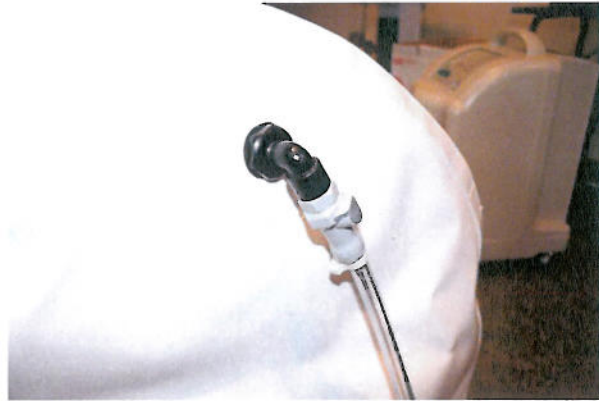
Photo 4

The air hose was connected to the chamber and the unit was pressurized by the detectives. Lieutenant Reyes “touched” the air hose quick disconnect button, the connection disengaged and the hose fell to the floor in a coil as previously noted. The detective’s investigation “revealed that the hose that pumped air into the chamber had a push release button, the hose was located on the back of the chamber, and when the chamber was pushed against the book shelf, the button became pushed by a clear plastic container lip sitting on the bookshelf”. The Detectives concluded that the clear plastic container had inadvertently depressed the release button on the quick release button allowing the critical supply air to the chamber to be disconnected. The loss of the critical supply of fresh air to the chamber would not allow the chamber interior to be maintained at the equilibrium value for carbon dioxide of less than 1% as stated by Oxy Health in the Oxy Health Operating and Reference Guide.

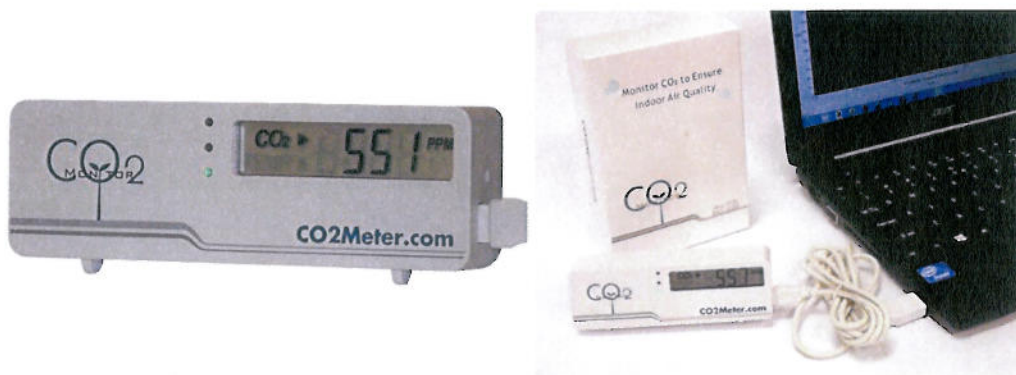
Figure A

Although, carbon dioxide monitoring is only required during saturation operations, which is not part of the operation sequence of the Oxy Health Model Vitaeris 320 hyperbaric chamber, NFPA recognizes the importance of monitoring and maintaining good breathing air quality. Carbon dioxide monitors and alarms are readily available in basic stand-alone or remote monitoring configurations. Many have adjustable warning levels and can also log carbon dioxide levels over time and download the information to a computer. One such simple solution, which is sold for \$109, is shown in figure A:

Oxy Health had a responsibility to identify hazards associated with the Oxy Health Model Vitaeris 320 hyperbaric chamber and to provide guarding to minimize the risk of injury. It would have been easy for Oxy Health to provide guarding that would have monitored the carbon dioxide (CO₂) levels within the chamber and also alarmed in the event that elevated carbon dioxide levels within the hyperbaric chamber were detected. Through the use of a simple carbon dioxide monitor, Oxy Health should have alerted the Sparks of a hazardous condition and prevented the carbon dioxide levels from reaching a dangerous level.

Without the use of a guard (carbon dioxide monitoring system), the Oxy Health Model Vitaeris 320 hyperbaric chamber was defective, unreasonably dangerous, unsafe for its intended use, and a cause of Jarred Sparks' asphyxiation.
